2006 Annual Site Inspection and Monitoring Report for Uranium Mill Tailings Radiation Control Act Title II Disposal Sites

November 2006

Work Performed by S.M. Stoller Corporation under DOE Contract No. DE-AC01-02GJ79491
for the U.S. Department of Energy Office of Legacy Management, Grand Junction, Colorado

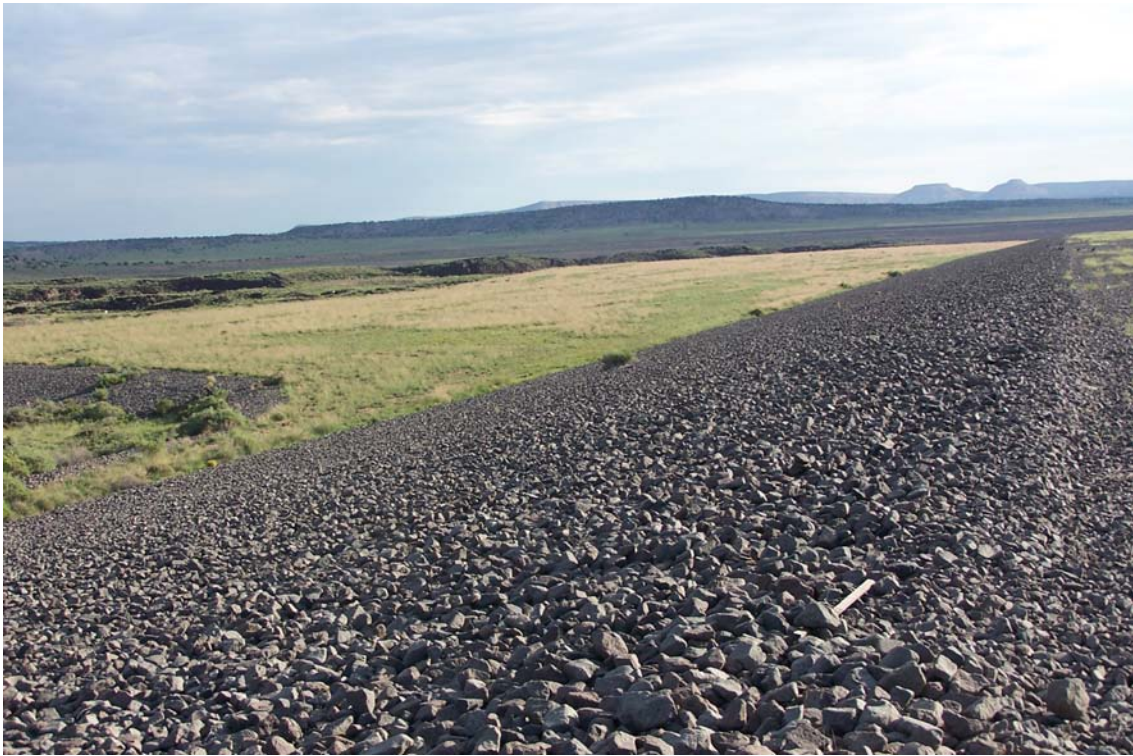
Main Tailings Disposal Cell, the Acid Tailings Disposal Area, and the South Bench Disposal Area—These three disposal areas are contiguous and together constitute one large disposal area of approximately 320 acres; all were in excellent condition. The main tailings disposal cell is covered with basalt riprap and slopes northward. The top slope grade decreases from 3 to 4 percent at the south end to less than 0.5 percent at the north end. The top slopes of the acid tailings (PL-1) and the south bench disposal areas are essentially flat and covered by healthy grass. The side slopes of the three disposal areas are protected by basalt riprap (PL-2). The riprap was in excellent condition.

BLU 8/2006. PL-1. Grass-covered acid tailings disposal cell; northwest side slope of the main tailings disposal cell is in the foreground.

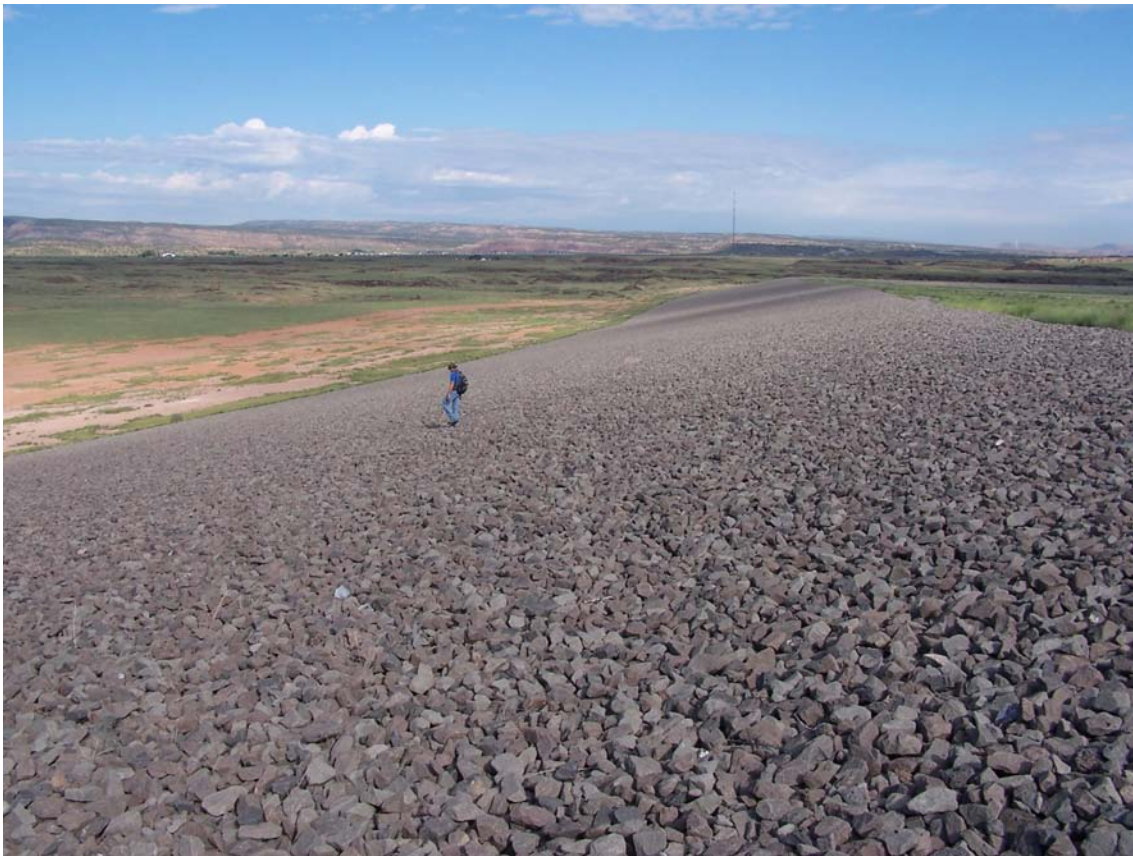
BLU 8/2006. PL-2 Southwest side slope of the main tailings disposal cell.

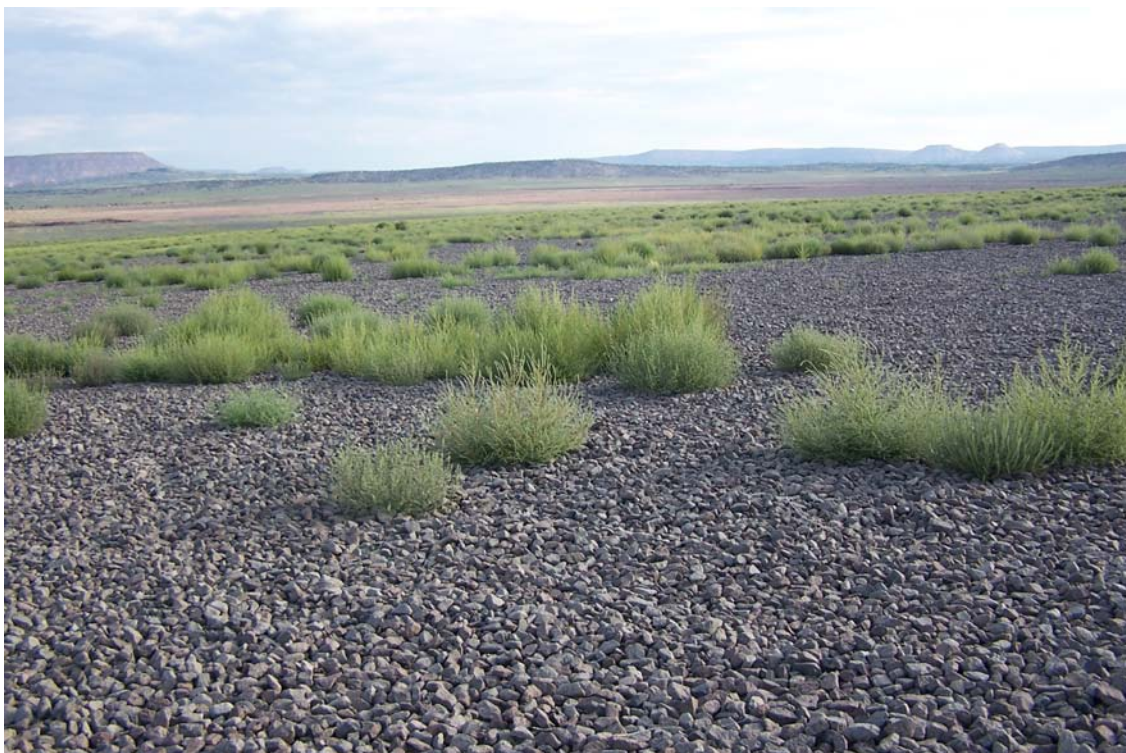
BLU 8/2006. PL-3. Top of the main tailings disposal cell viewed from the southwest corner.

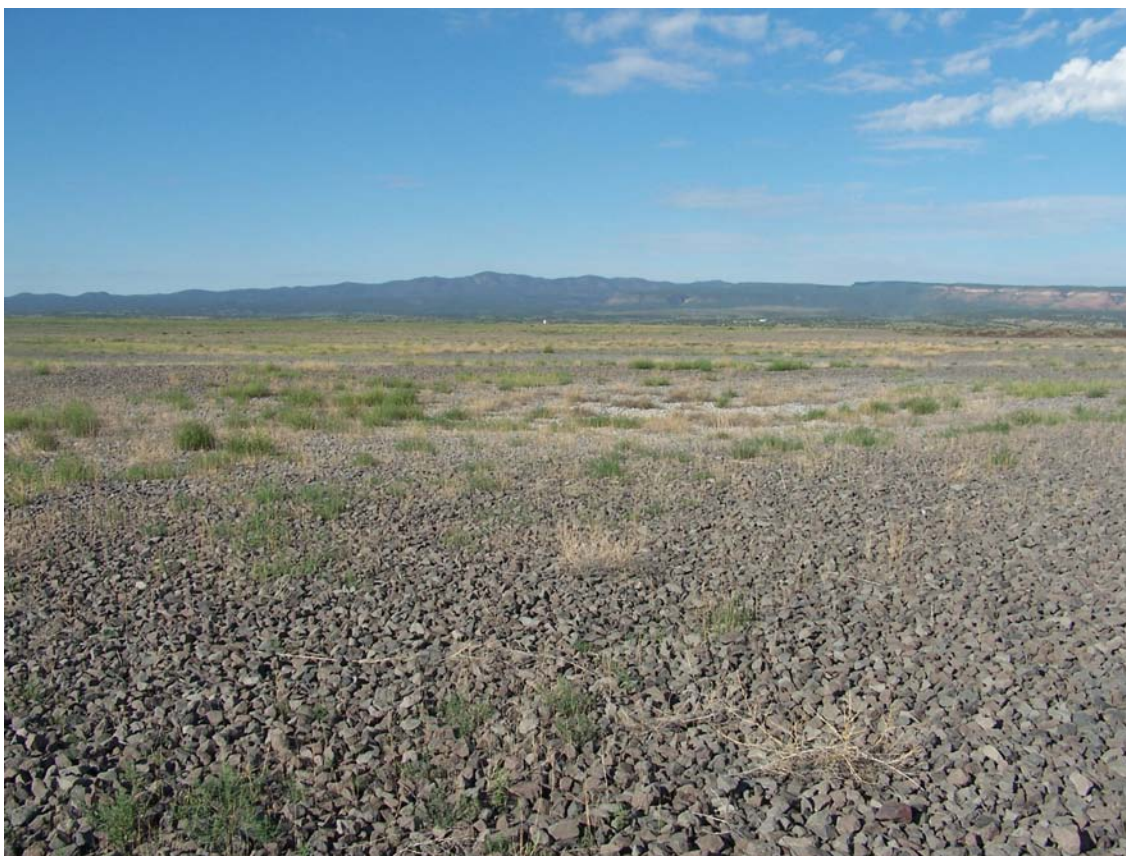
Several small shallow depressions exist on the relatively flat north end of the top slope of the main tailings disposal cell. Although ponded water has been observed in the past, the depressions were dry at the time of the inspection. Slimes from the settling ponds were placed in the northern part of the main tailings disposal cell and areas containing slimes are more likely to settle than areas containing drier waste materials. One depression appeared to be deeper than observed during the 2005 inspection (PL-4). The depressions will continue to be monitored for evidence of significant settling or displacement. Given that evaporation greatly exceeds precipitation in this area, ponding is believed to be infrequent and brief and, therefore, is not a concern.

BLU 8/2006. PL-4. Dry depression near the north edge of the main tailings disposal cell cover.

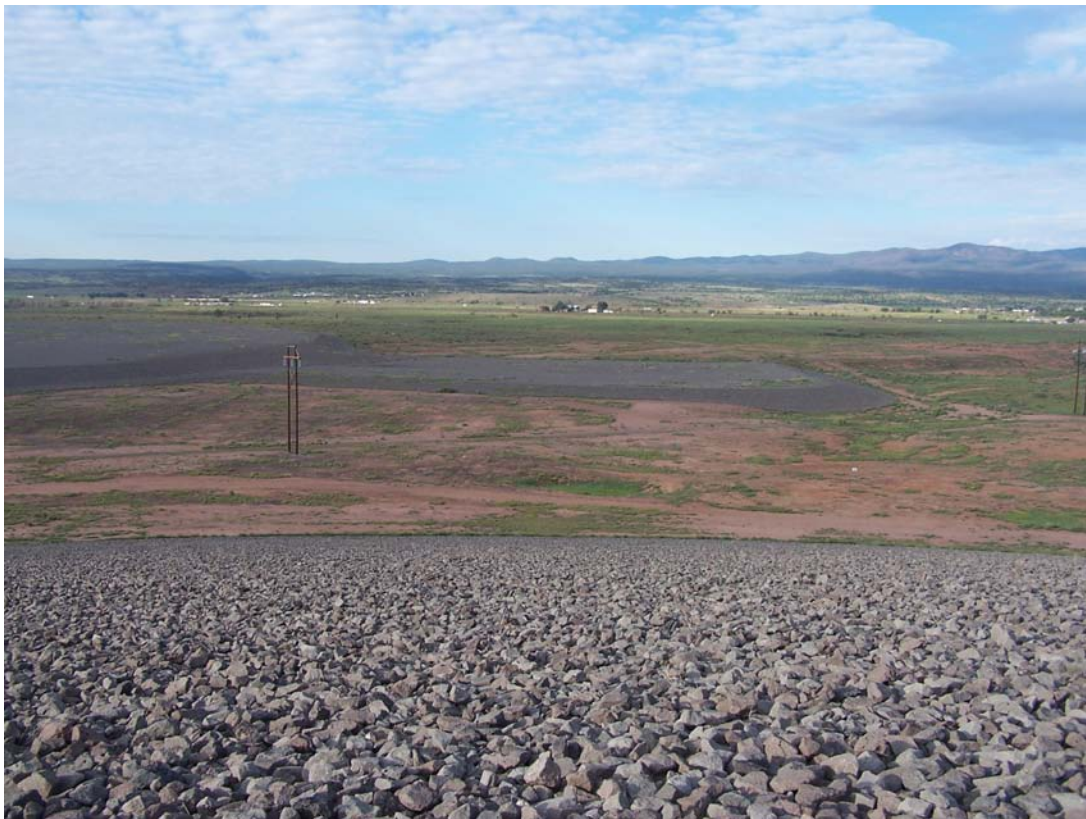
BLU 8/2006. PL-5. Northwest extension of the carbonate tailings disposal cell.

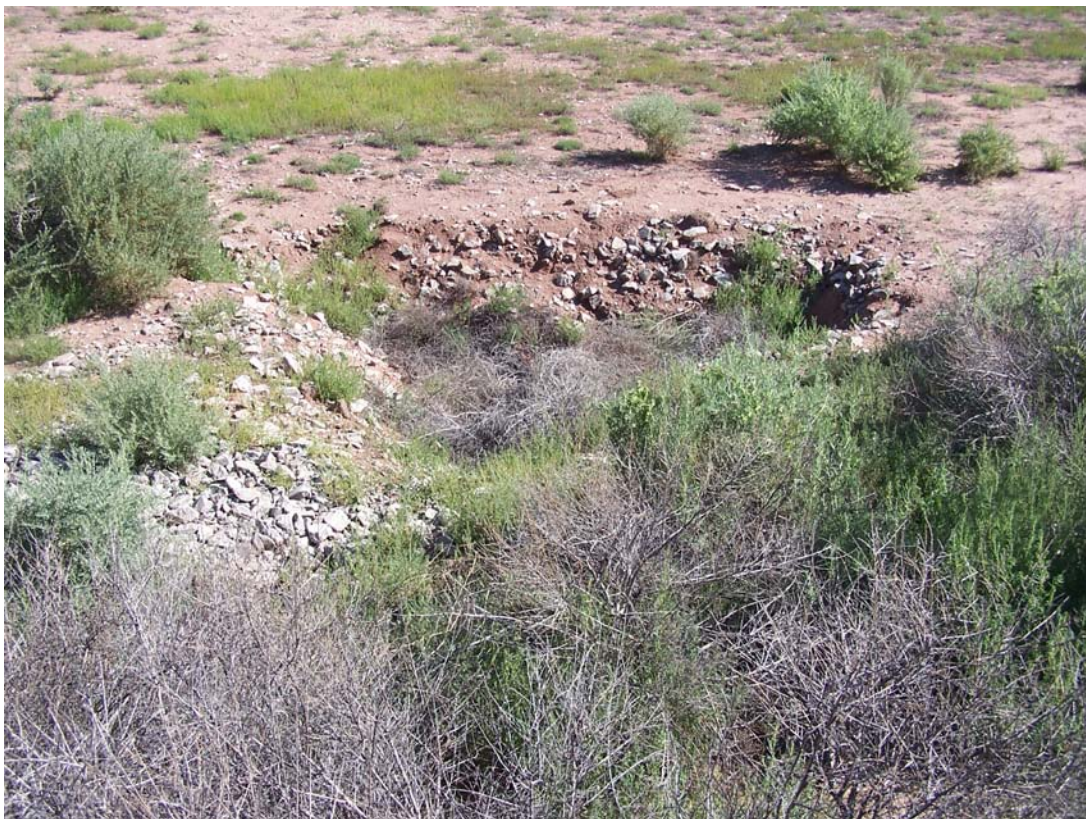
1C The asbestos disposal area is a bowl-like feature or depression just south of the carbonate pile. The north, west, and south side slopes of this depression are covered by limestone riprap; the bottom of the bowl is grass covered. A small depression is located along the south edge of the disposal area, and could represent piping or collapse of uncontaminated fill material incompletely compacted during final grading (PL-6). The depression was first noted during the 1999 annual inspection but has not been a concern because it does not encroach on asbestos-containing materials. However, to mitigate the potential for encroachment into these materials, the depression is scheduled to be filled with crushed basalt rock in 2007. Potential access routes to haul crushed rock to the disposal area were investigated. Other than the depression, the disposal area is in excellent condition.

BLU 8/2006. PL-6. Depression in the asbestos disposal area.

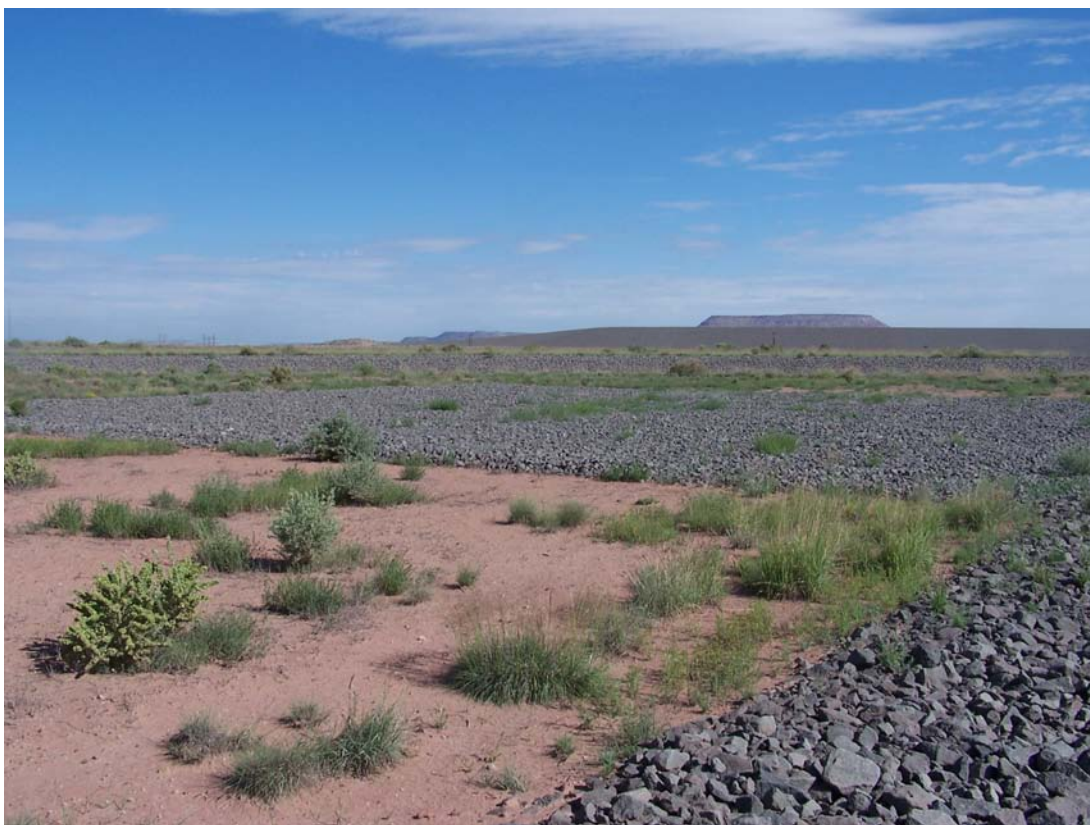
The small riprap-covered PCB disposal area is in excellent condition (PL-7). The two grass-covered landfill areas east of the carbonate tailings disposal cell also are in excellent condition. Two other disposal areas, Disposal Area Number 1 and the Stockpile Area, are south of the carbonate tailings disposal cell. Both are grass-covered and in excellent condition.

BLU 8/2006. PL-7. Basalt cover of the PCB disposal area.

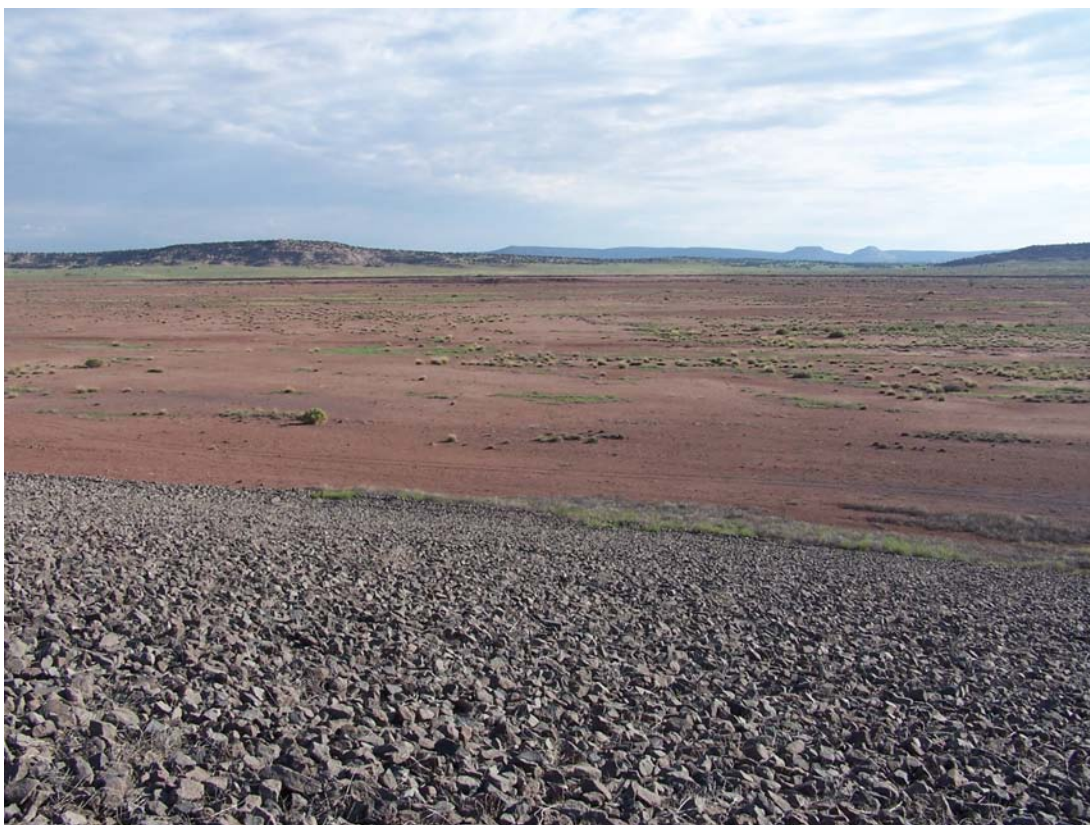
BLU 8/2006. PL-8. Barren terrain viewed from the northeast corner of the main tailings disposal cell.

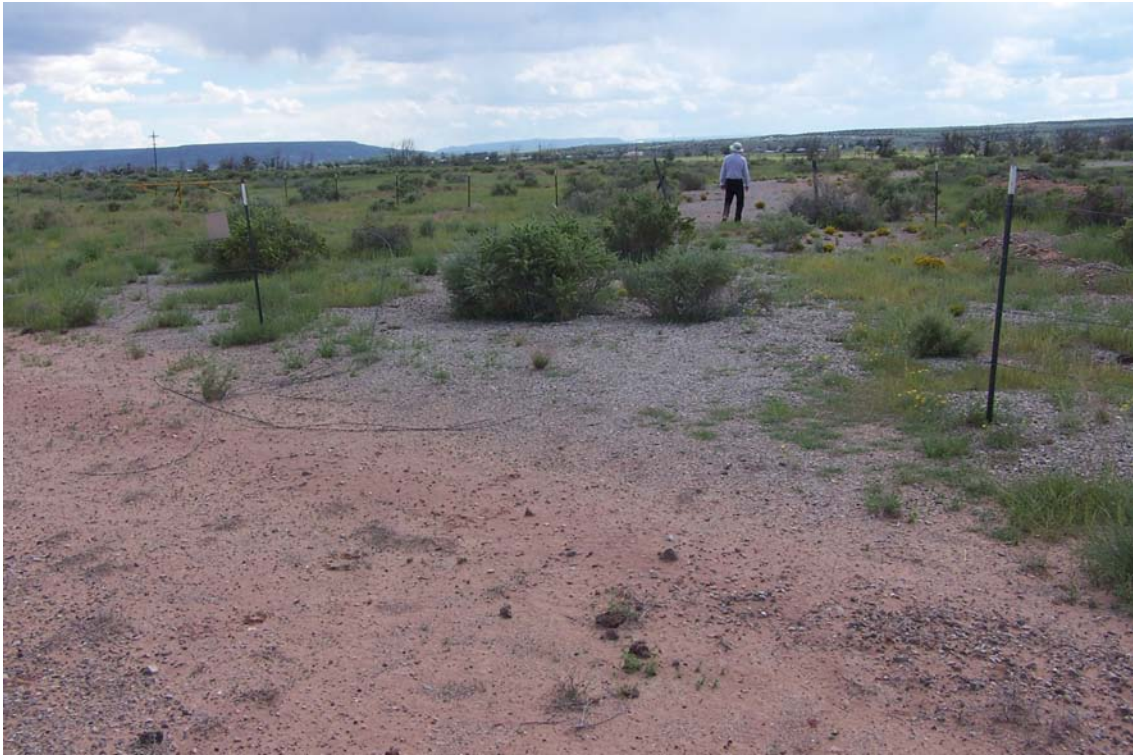
BLU 8/2006. PL-9. Cut section of the barbed-wire perimeter fence along the south property boundary.

During 2006, old pump equipment and stock tanks were removed, a cut section of the perimeter fence was repaired, and legacy radioactivity warning signs were removed. The site was checked on a monthly basis by a local subcontractor for evidence of trespassing and to ensure that the perimeter fence is intact.

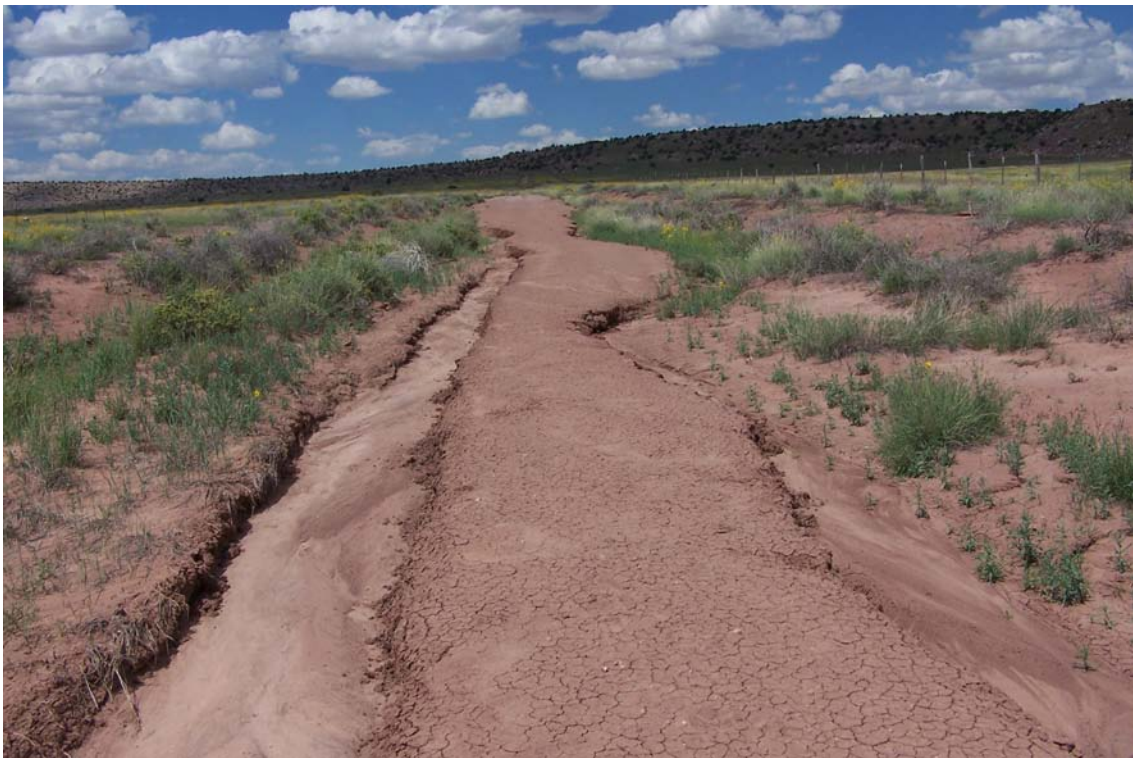
The perimeter road consists of a dirt track covered at places with crushed basalt. The road runs along the site boundary in much of the southern and most of the northern and eastern parts of the site. Erosion has occurred along portions of the road, but an evaluation in fall 2005 indicated that the eroded areas could easily be bypassed and that repairs were not needed at the time. Runoff from above-normal rainfall during summer 2006 has deepened gullies and washed out sections of the road along the northeast perimeter of the site (PL-10). Although these sections can be bypassed during dry conditions, the need for repairs will again be evaluated.

BLU 8/2006. PL-10. Gully erosion on the perimeter road near monitor well MW-I(SG).

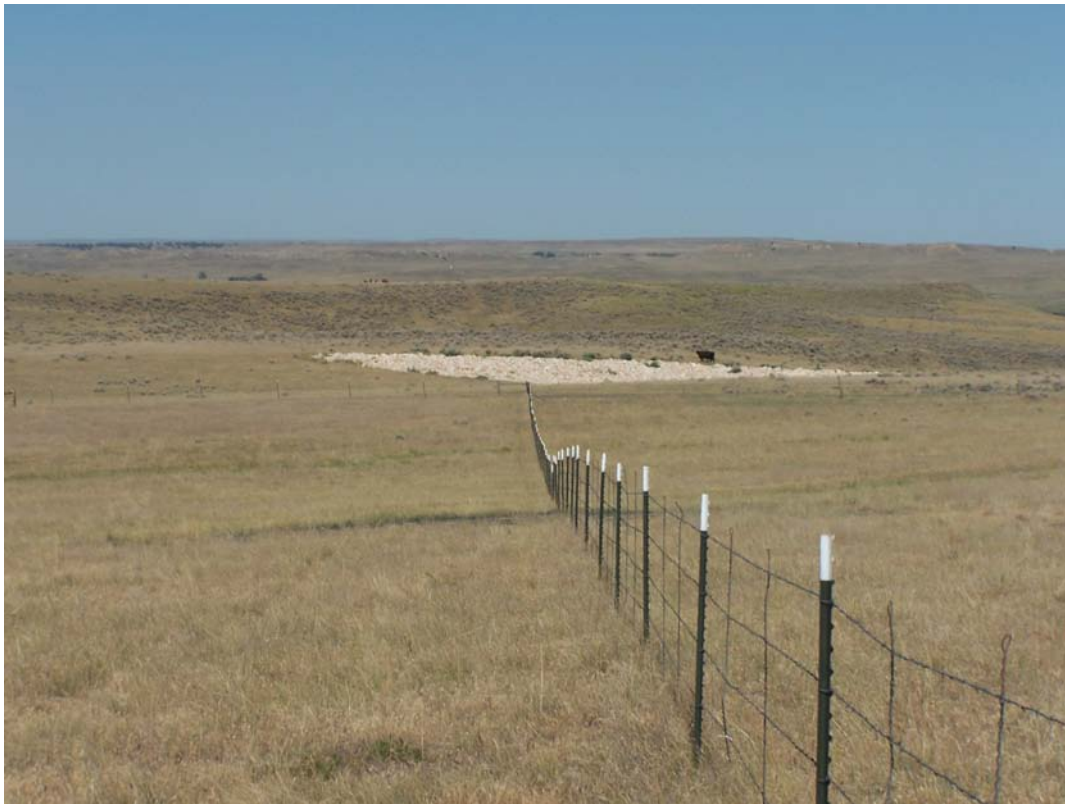
A four-strand barbed wire fence was installed in spring 1999 along the site perimeter boundary to demarcate DOE property and to control grazing on the property. The fence is truncated at the southeast corner to allow livestock access to a pre-existing stock pond. Except for a short portion along the east boundary, where cattle were present, inspectors walked the site perimeter to assess the integrity of the fence. The fence was in excellent condition (PL-1).

EDG 6/2006. PL-1. Perimeter fence and riprap-armored drainage area near the northwest corner of the site.

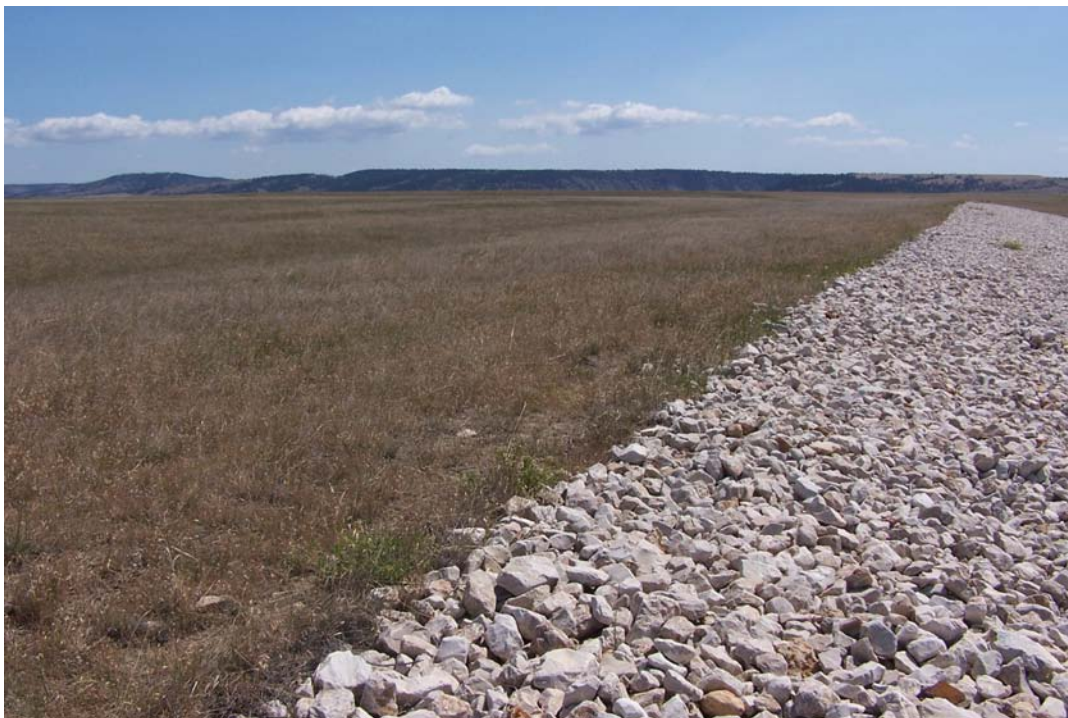
Top of the Disposal Cell—The 100-acre top of the disposal cell, completed in 1989, is grass-covered and was in excellent condition (PL-2). DOE manages the grass cover through controlled grazing. The grass is well established and was not over-grazed when inspected. Numerous cattle trails are present on the cell top, but there were no indications of erosion, settlement, or other modifying processes that might affect the integrity of the cell.

EDG 6/2006. PL-2. Contact between the grass-covered disposal cell top and the riprap-armored tailings embankment.

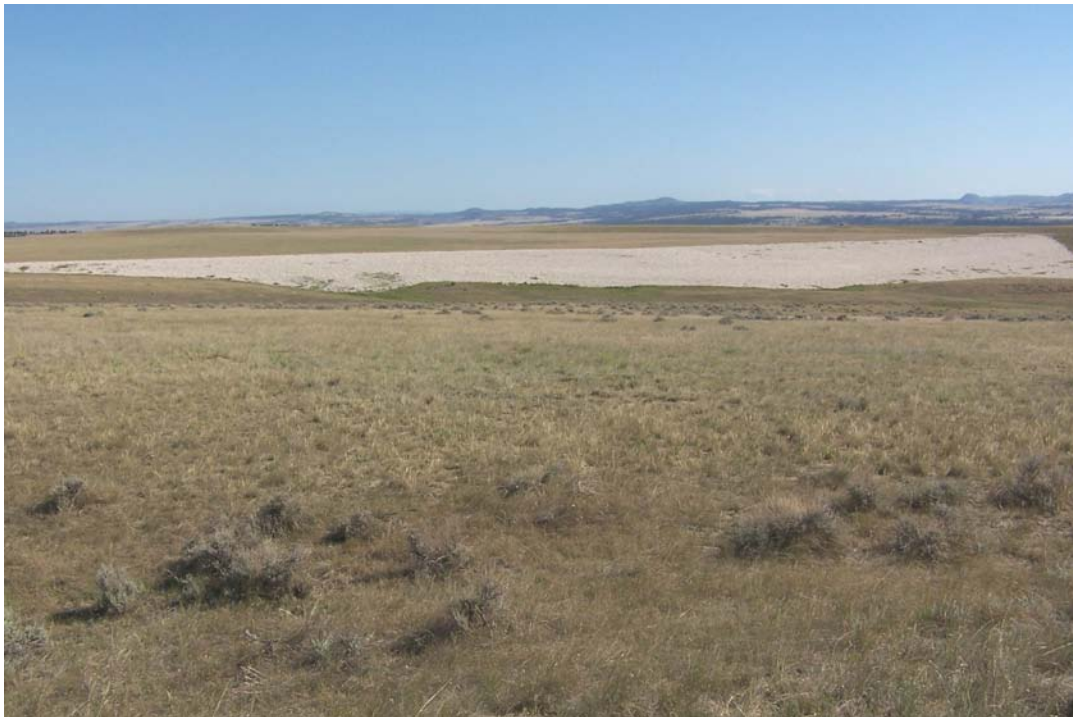
EDG 6/2006. PL-3. Tailings embankment.

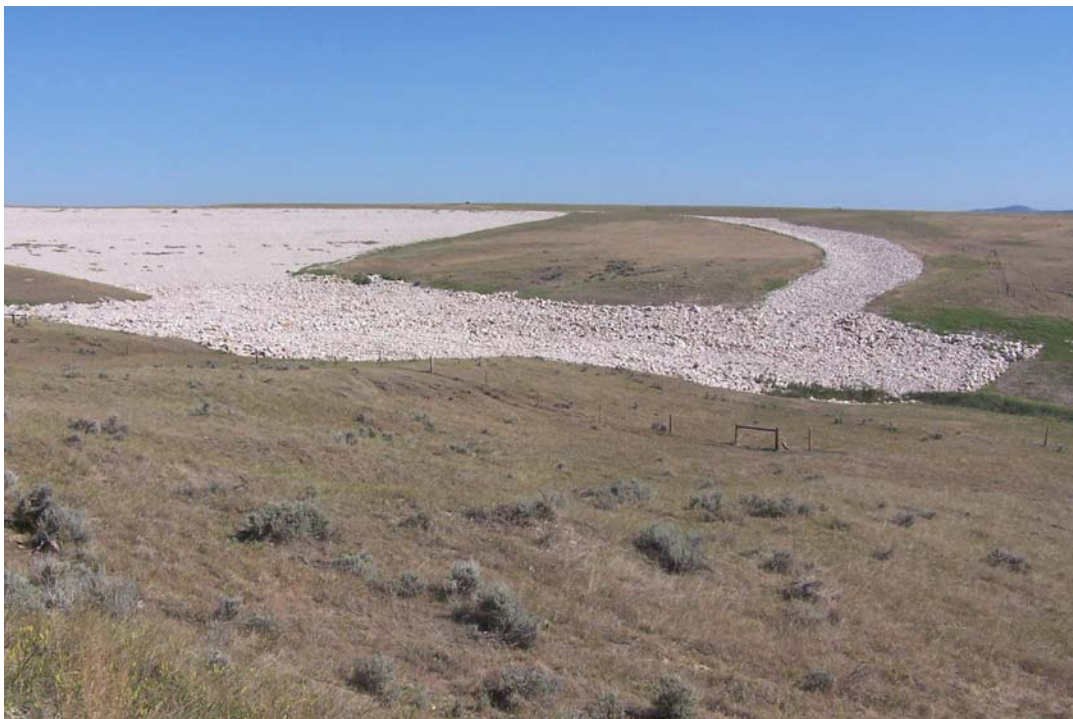
EDG 6/2006. PL-4. Tailings embankment, drainage channel, and east diversion channel.

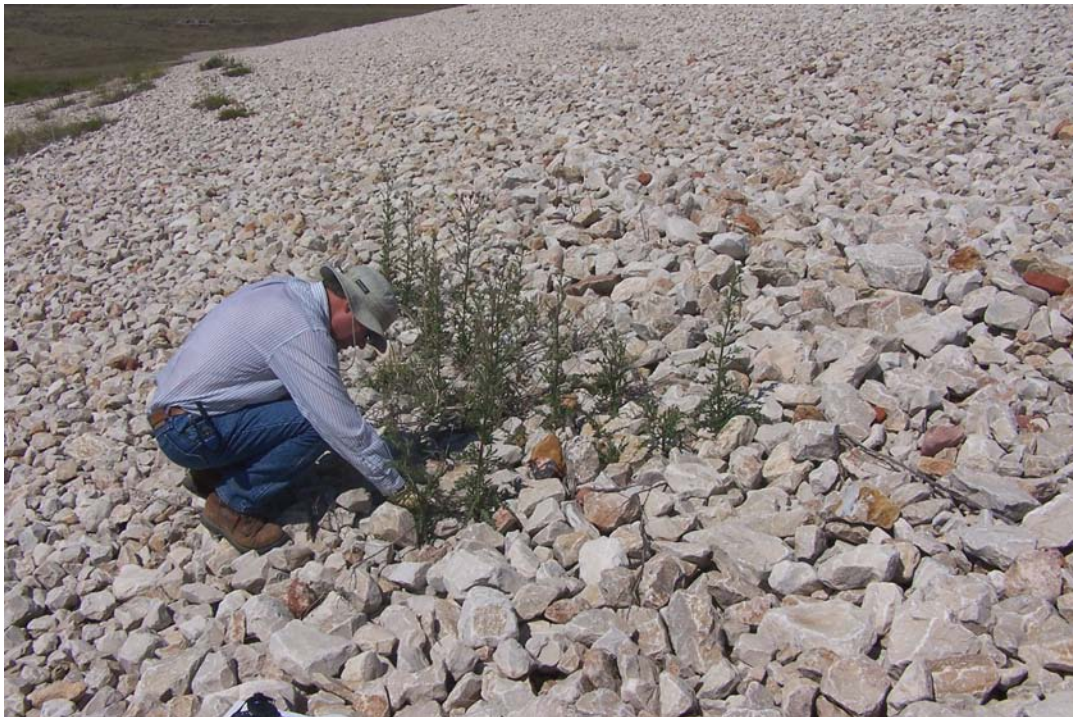
- 2A DOE has retained the Fall River County weed control agent to spray Canada thistle, a noxious weed persisting on the site, since 1998. The thistle usually has been found growing on and along the edges of the riprap-armored surfaces. Although only one small patch of Canada thistle was found and subsequently sprayed in 2005, numerous patches were present at the time of the 2006 inspection (PL-5). These patches subsequently were sprayed with herbicide by the county.

EDG 6/2006. PL-5. Patch of Canada thistle on the tailings embankment.

Noxious weeds were sprayed with herbicide in 2006. No other maintenance or repairs were required.

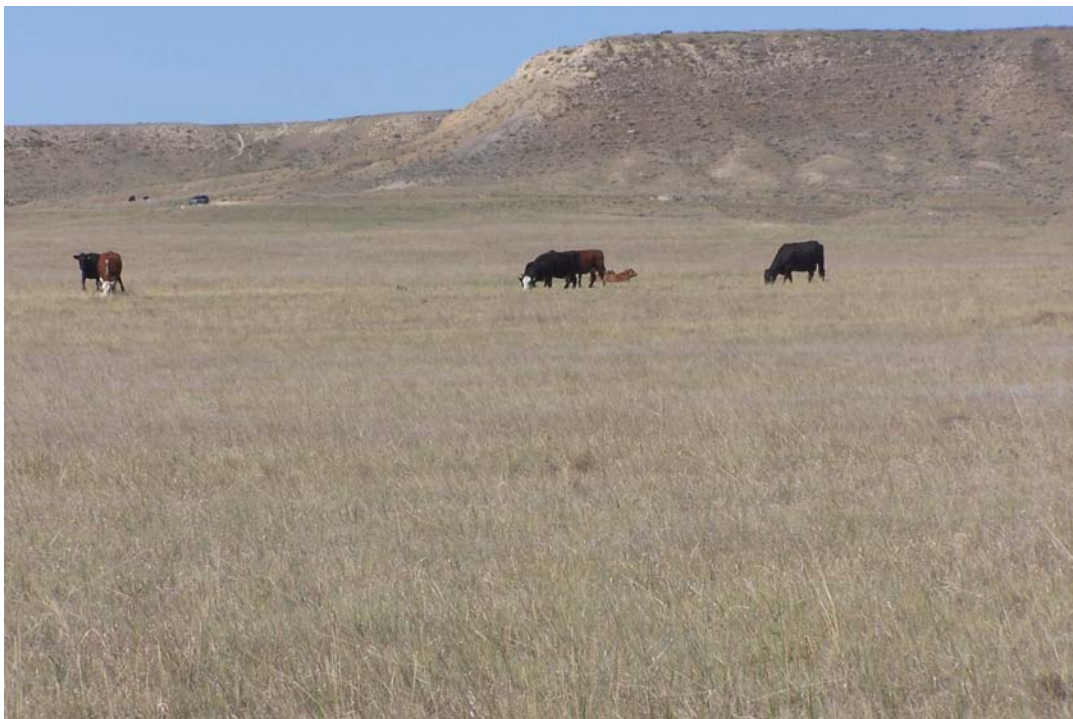
EDG 6/2006. PL-6. Cattle grazing on the site east of the disposal cell.

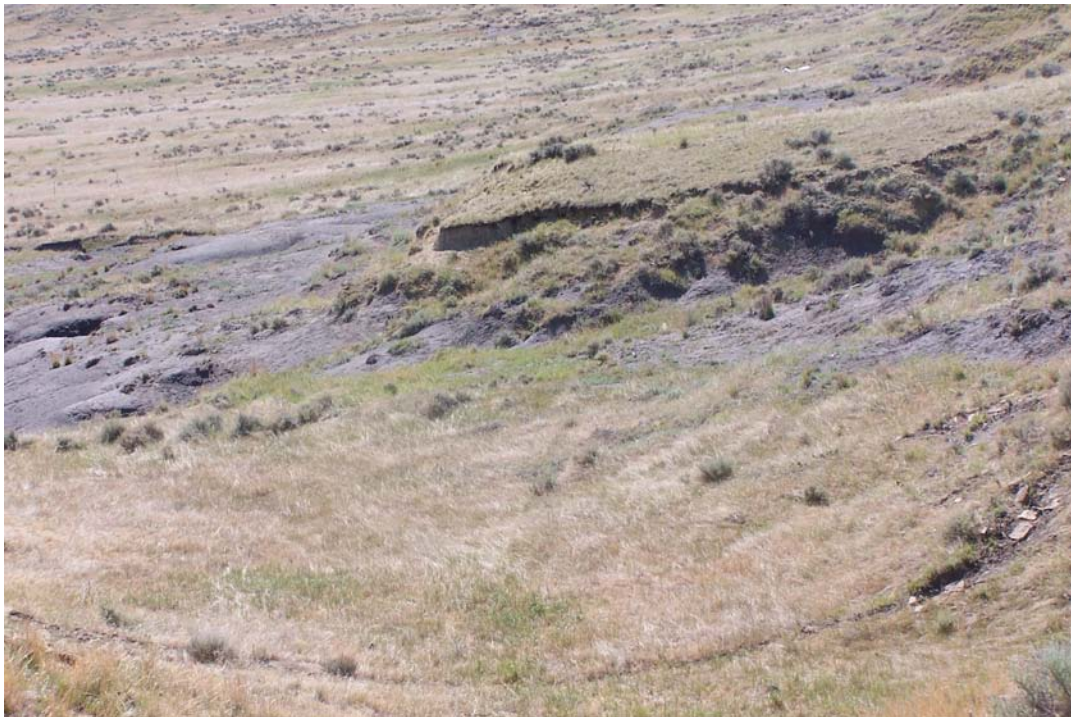
Region Between the Disposal Cell and the Site Perimeter—The area between the disposal cell and the site perimeter is grass-covered and in excellent condition. This region also is grazed in a controlled manner, and cattle were present on the site the day of the inspection (PL-6). The grass is well established but minor erosion persists on undisturbed steeper portions of the site east of a natural ridge that separates the east portion of the site from the area containing the cell (PL-7). This erosion does not threaten the integrity of the stabilized tailings.

EDG 6/2006. PL-7. Minor natural erosion occurring in an undisturbed area in the southeast portion of the site.

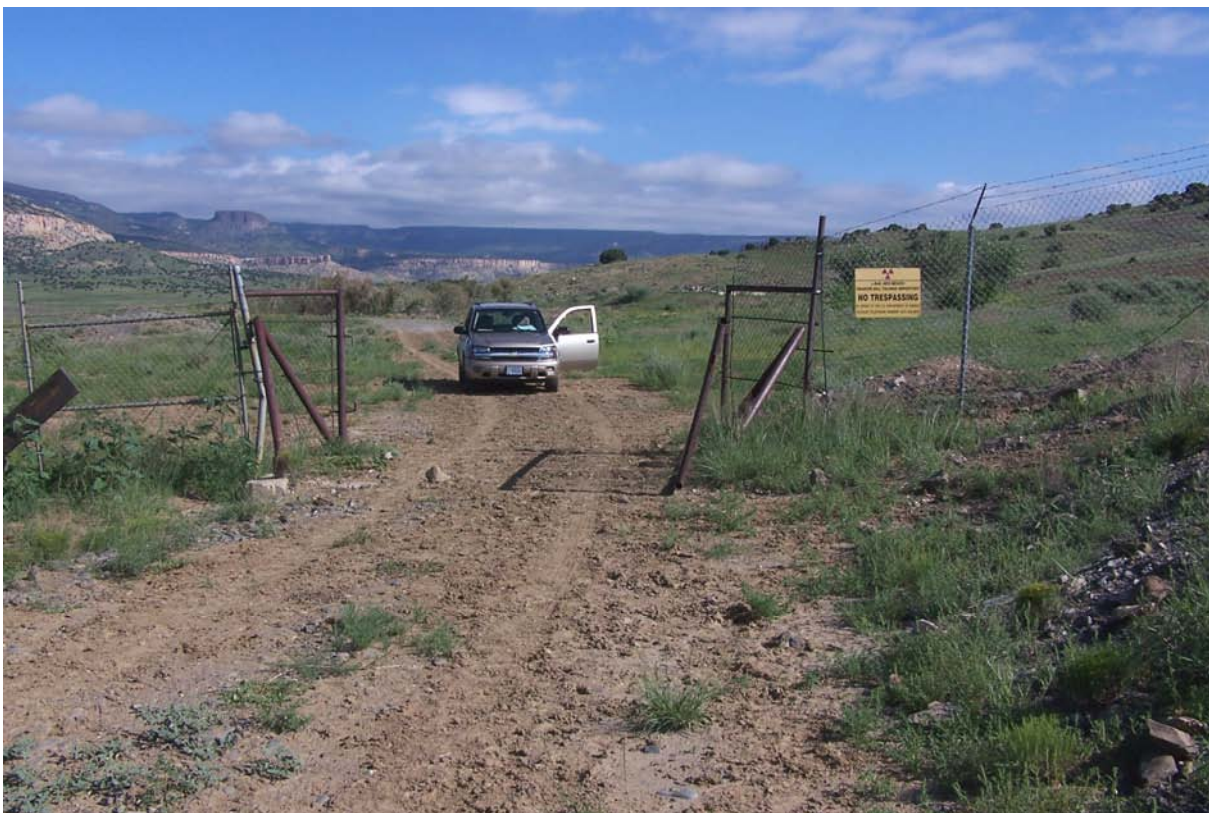
BAR 8/2006. PL-1. Damaged chain-link fence gate located in the southeast corner of the site.

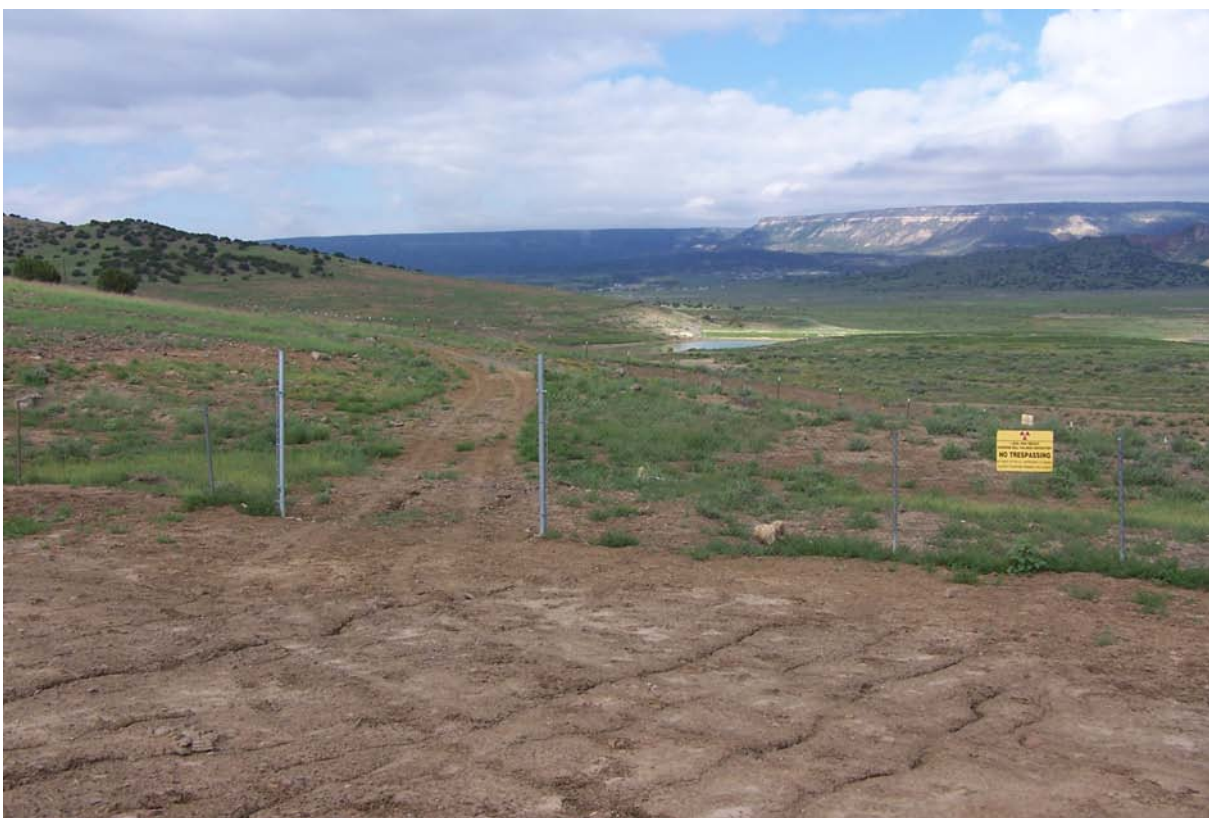
BAR 8/2006. PL-2. Missing chain-link fence gate located on the east side of the site.

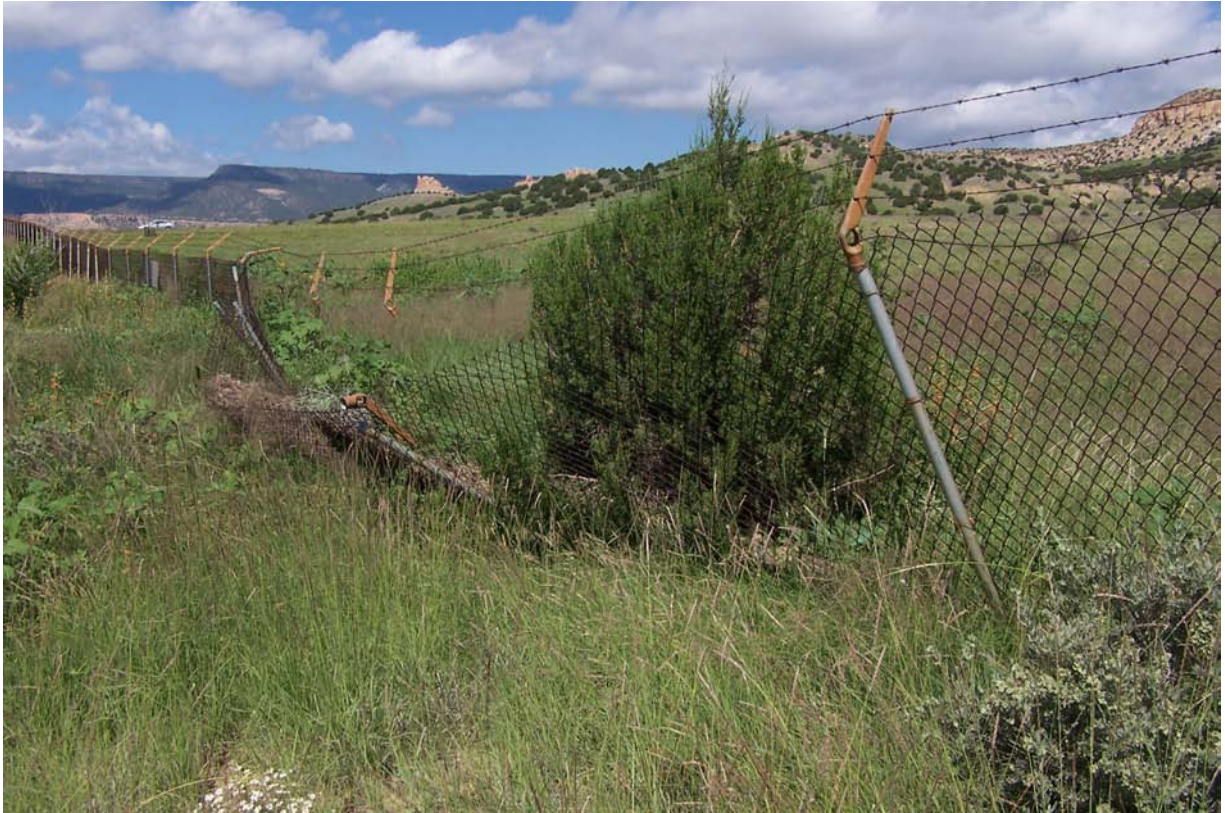
BAR 8/2006. PL-3. Runoff-damaged section of chain-link fence east of the site access gate.

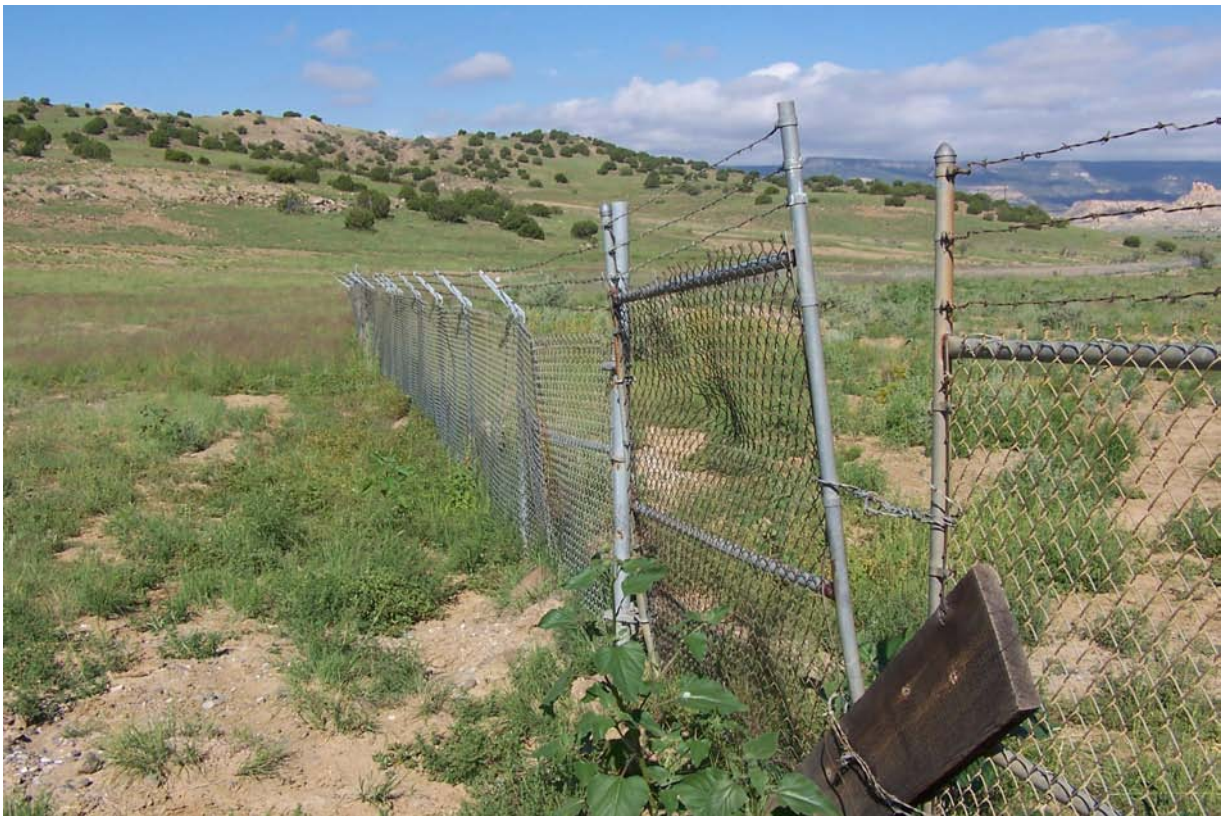
BAR 8/2006. PL-4. Poor condition of the chain-link fence in the southeast corner of the site.

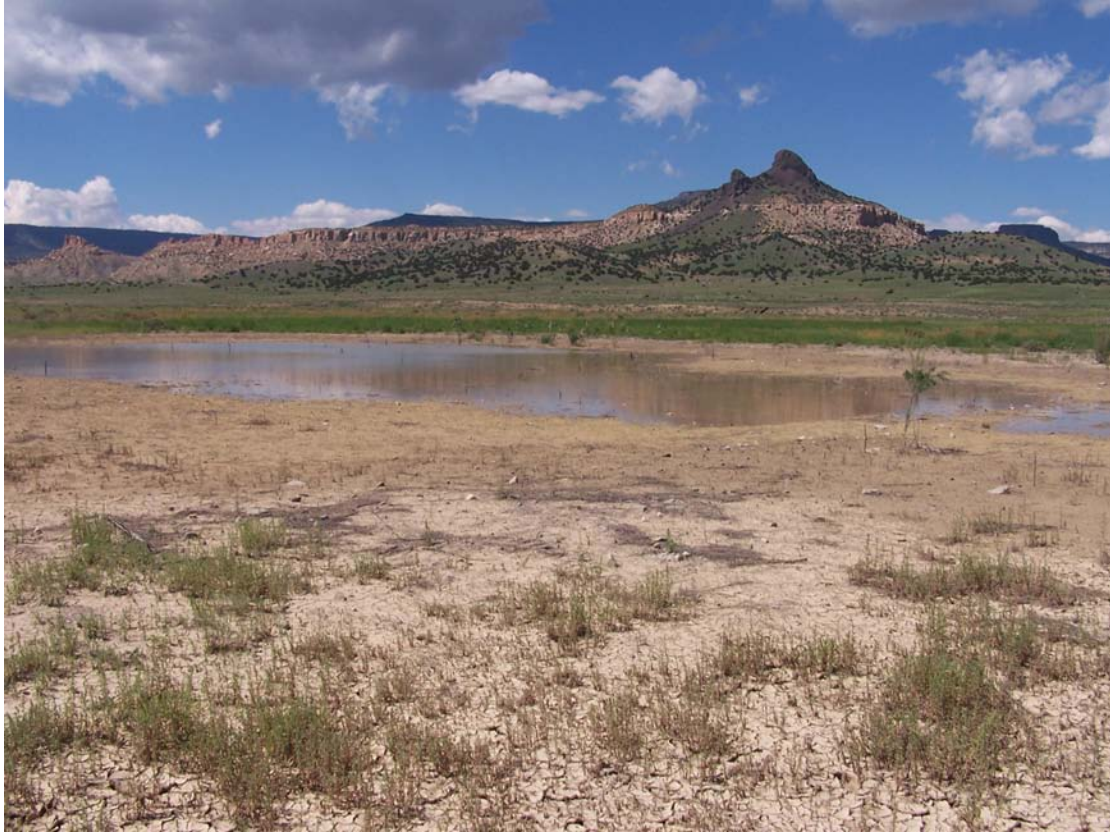
BAR 8/2006. PL-5. Standing water in a shallow windblown depression on the impoundment cover.

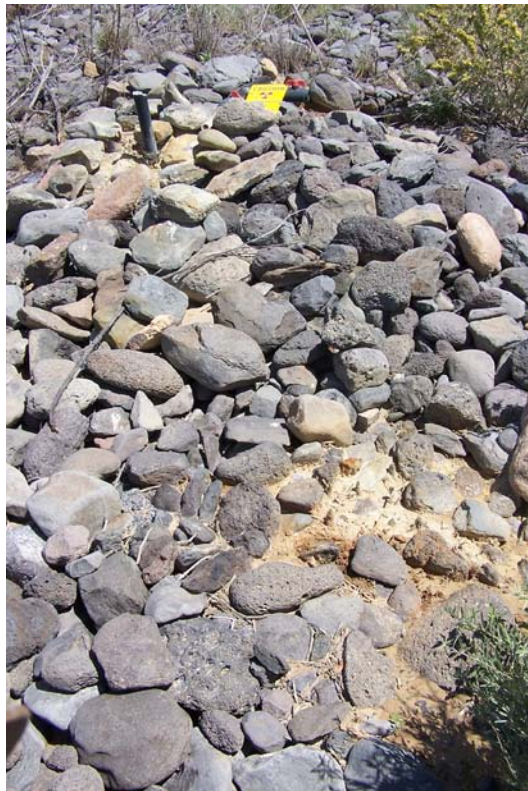
BAR 8/2006. PL-6. Contaminated drain outlet #2 at the base of the containment dam.

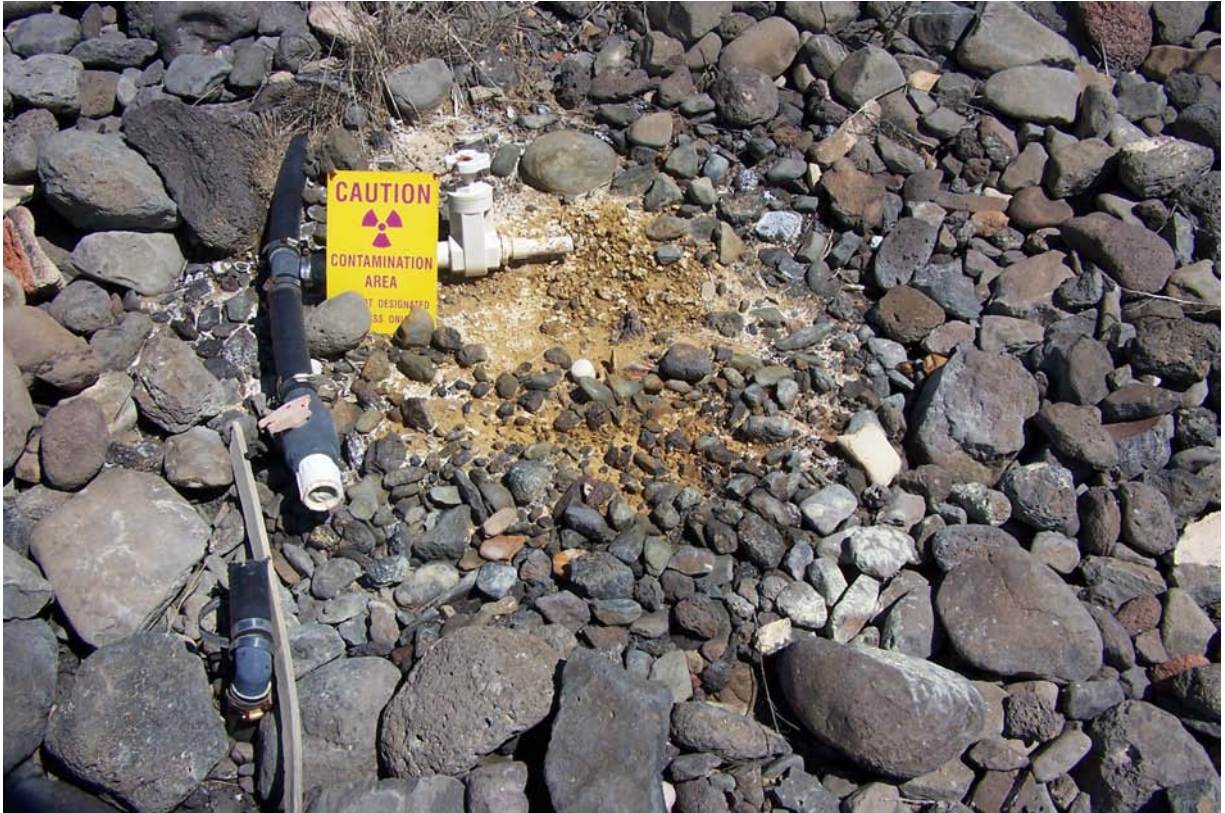
BAR 8/2006. PL-7. Contaminated drain outlet #4 at the base of the containment dam.
